Restoring discoloured uncoated timber cladding

Peter Kaczmar

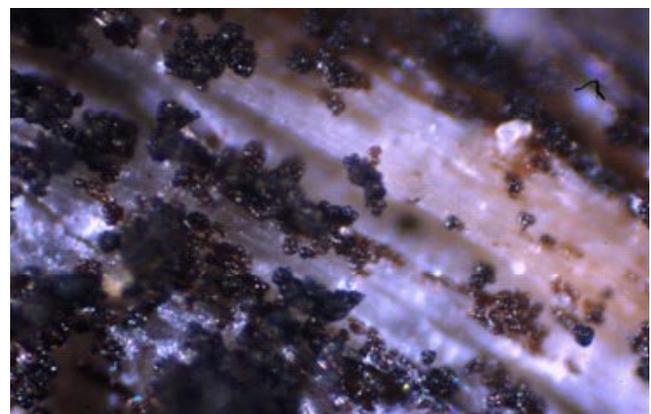
The discoloration referred to as ‘mould’ growth was found to be caused by a melanized or black form of yeast fungus from the genera *Aureobasidium* or *Hormonema*, which produces a characteristic black discoloration on new and weathered wood (*Figure 2*).

Figure 2 Melanized surface yeast growing on oak

The fungal organism uses naturally occurring sugars present in the wood, as well as the breakdown products of delignification, and requires moisture in order to sustain growth. This type of discoloration is most prevalent on unprotected aspects which are subjected to high levels of solar radiation. It is much less of a problem on areas which are sheltered from direct sunlight and rainfall, such as beneath eaves, overhangs and canopies (Figure 3).

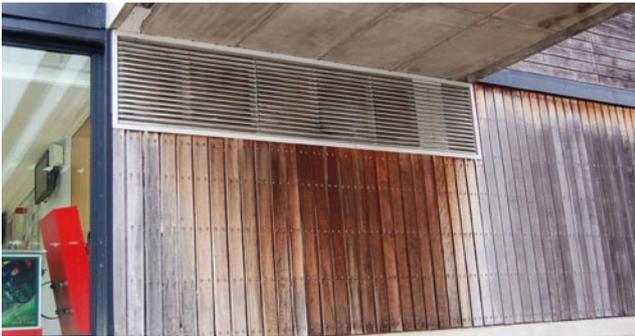
Figure 3 Typical shadow lines on cladding caused by differential weathering

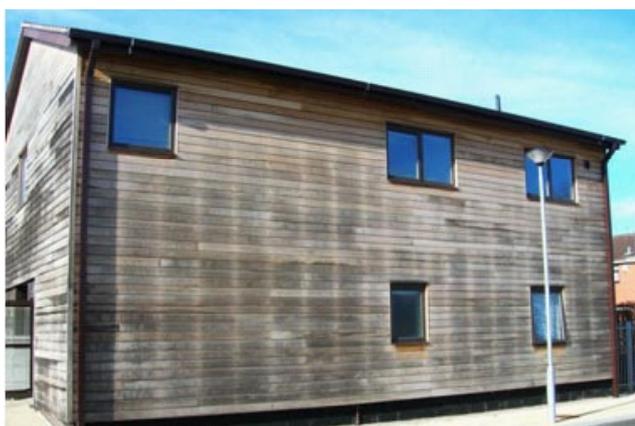
The manner in which cladding is fixed can also influence the development of this type of disfigurement. Discoloration by surface yeasts can cause the development of ‘shadow lines’, which often can be seen running down areas of cladding and which can mimic or shadow the presence of fixing battens, particularly if the inner wall of the building is not provided with an adequate vapour barrier. This can occur on close-jointed cladding, where warm air from the interior of the building can migrate into the back of the cladding, condense and prompt fungal disfigurement on the cladding surface (Figure 4).

Figure 4 Light vertical lines on close-jointed oak cladding

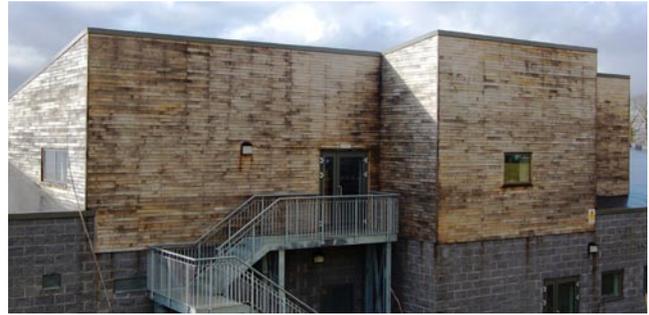
In cases where the cladding is open-jointed, rainwater penetrating past the rainscreen can be channelled down the fixing battens and held against the backs of the boards to create localized discoloration along lines of battens as vertical dark bands (Figure 5).

Figure 5 Dark vertical lines on open-jointed sweet chestnut cladding

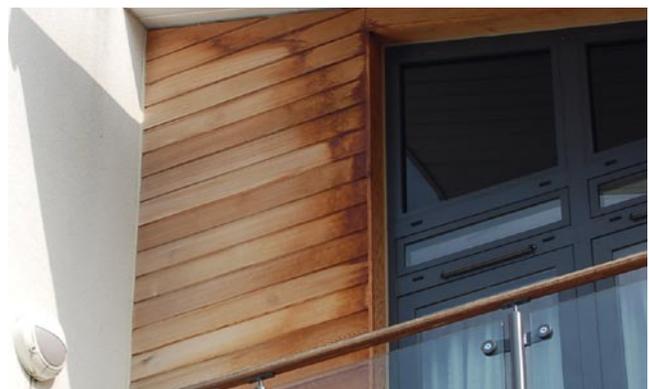
It is especially important to consider the water-shedding dynamics of buildings at the design stage, particularly if unusual designs are proposed, since the manner in which water is shed down the building may be a factor in determining whether this form of staining is likely to develop. The research indicated that this form of staining occurs as a tenuous surface phenomenon which, in severe cases, can form a discrete zone of extractives at the surface (Figures 6 and 7).

Figure 6 Extractive staining on western red cedar beneath break in eaves canopy

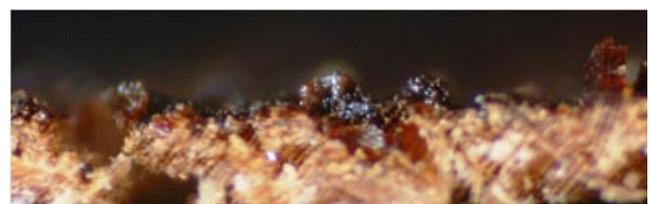
Figure 7 Transverse section taken from surface of western red cedar cladding with severe extractive staining, showing dark-coloured extractives confined to the surface zone

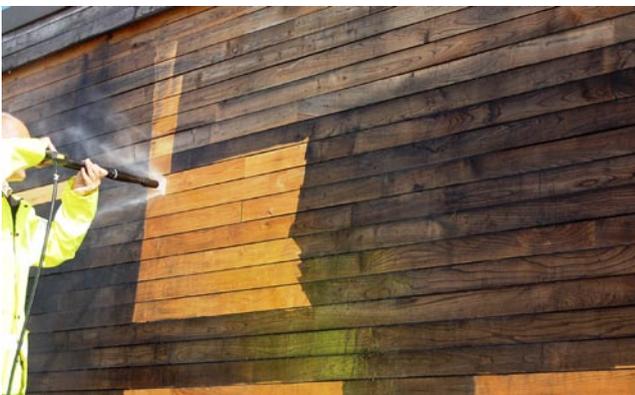
Figure 8 Surface cleaning of discoloured sweet chestnut cladding using a domestic pressure washer

Given that the *Aureobasidium* existed as a surface growth, attempts were also made to remove the discoloration by pressure-washing with water. This proved to be an extremely effective, quick and easy method of removal of the surface growth and enabled large tracts of cladding to be cleaned with a single pass of the water jet (*Figure 8*).

The process of pressure-washing also removed the friable zone of delignified surface fibres on the wood caused by the process of weathering, restoring the original colour of the wood. In addition, it was effective against disfigurement caused by tannin redistribution. This meant that the same process could be used to remove three of the four principal causes of discoloration identified by the literature review as being the most problematic to consumers, (i.e. bleaching/surface greying, tannin staining and mould discoloration).

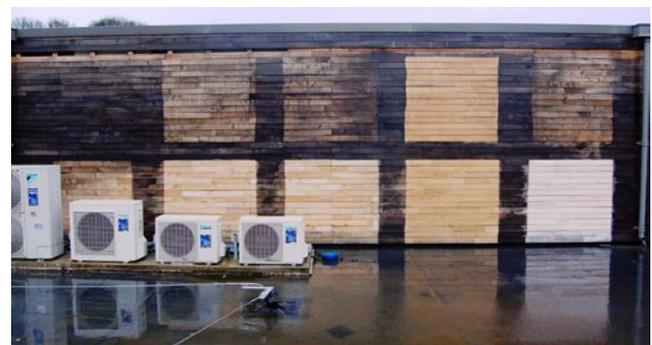
Some test areas were left in their cleaned condition with no treatment, in order to investigate whether any residual uptake of the cleaning products used (bleach, sodium hydroxide, etc) conferred any long-term protection against the re-colonization of the surface micro-organisms (*Figures 9 and 10*).

Figure 9 Test areas on sweet chestnut 14 months after cleaning, showing differential levels of re-colonization according to treatment

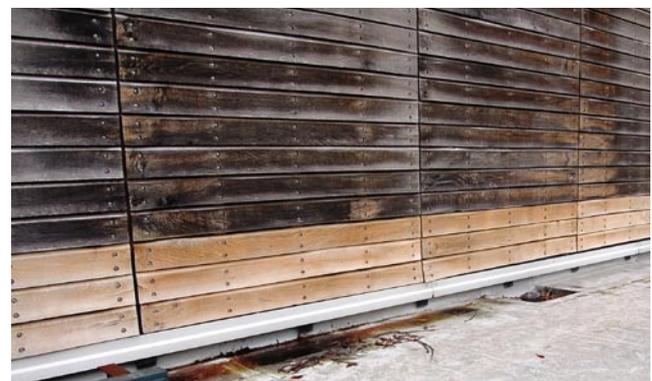
Figure 10 Test bays on oak cladding immediately following cleaning and treatment

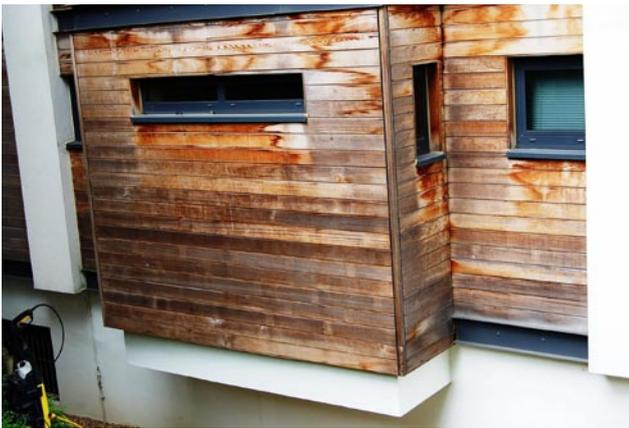
Figure 11 Discoloured western red cedar cladding before cleaning and treatment

Pressure-washing was found to be the most effective method of cleaning discoloured cladding. In one field case study, the opportunity arose to demonstrate the process to good effect on a three-storey building project. The facade was clad with horizontal close-jointed western red cedar boards, pressure-washed and then treated with a colourless, resin-based decking-protection product as an expedient to prevent the re-emergence of discoloration and extractive staining (compare *Figures 11 and 12*).

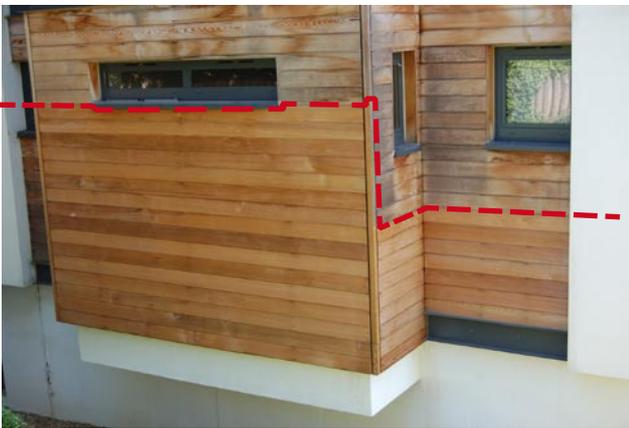
Figure 12 Discoloured western red cedar cladding following cleaning and re-treatment
